## Muck Reduction of 55.8% - A Report on the Effectiveness of Vertex Aeration to Eliminate Accumulated Sediment

***A report commissioned by an independent party (in Michigan, USA) demonstrates the reduction of organic lake bottom sediments after the installation of a properly designed aeration system.***

# Aeration of East Twin Lake Sediment, BOD and Oxygen Results

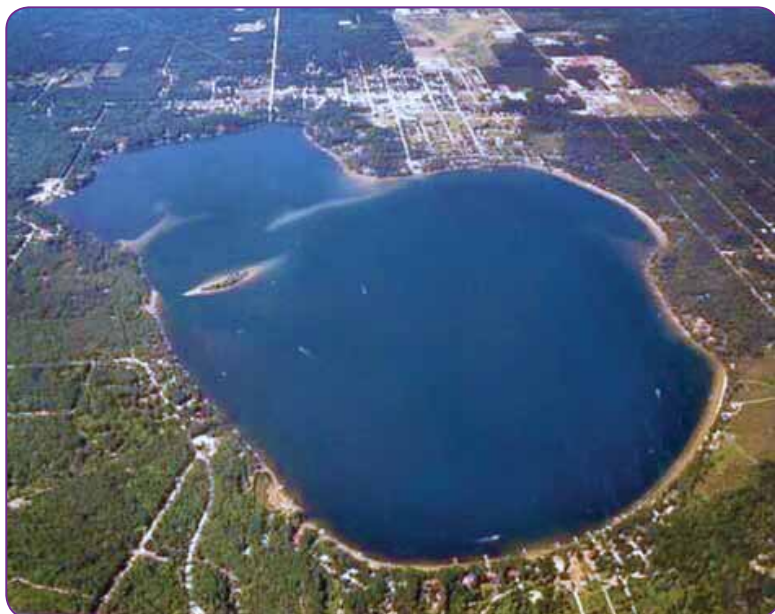
### East Twin Lake Aeration Study

Site map of sediment location, depth contours, sampling locations and Vertex aerator placements

Our aeration effort is concentrated in the lake's west end where the sediment problem was most prominent. We contracted for the purchase and installation of eight land-based compressors that would each feed three diffuser units. Each diffuser unit consists of four rubberized membranes containing multiple tiny holes. In total, the four compressors would feed 24 diffuser units consisting of 96 membrane bubbleers.

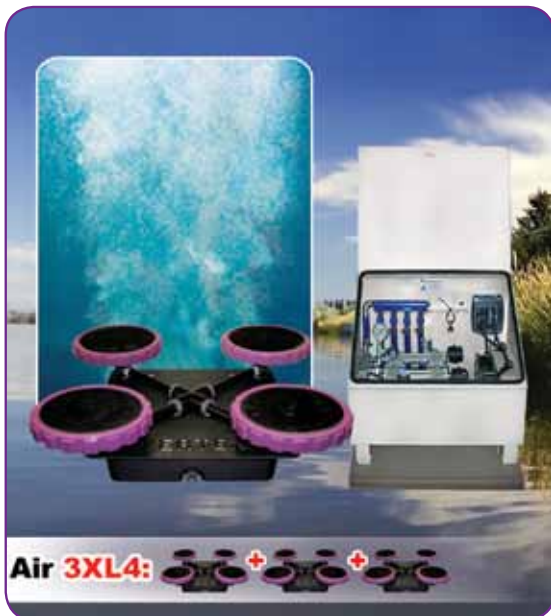
## Eight Vertex Air3 XL4™ Systems installed at East Twin Lake Cove

The Vertex Air3 XL4™ pond aerator is a super-efficient, affordable and safe system. In a typical pond, an Air3 XL4™ can aerate approximately 4-7 acres depending on shape, slope, oxygen demand and other factors. Two 1/2hp (0.75kW) Brookwood™ SafeStart™ compressors, housed in our rustproof aluminum outdoor cabinet, feed three bottom mounted XL AirStations™ utilizing Vertex's MicronBubble™ technology.

The rising force of millions of bubbles circulates the entire water column, entraining bottom water up to the surface allowing vital oxygen to be absorbed and poisonous gasses expelled. With no electricity in the water, Vertex's aeration systems are safe for any type of water recreation.

- ◆ 24 XL4 AirStations: (96) 9" flexible membrane discs
- ◆ 8 QuietAir Cabinets: (16) 1/2hp Brookwood Compressors
