## Increased Oxygen to Promote Stratification Reduction

Heron Cay, a high-end gated residential development in South Florida, was experiencing a number of problems in their 21-acre lake which is central to the community.

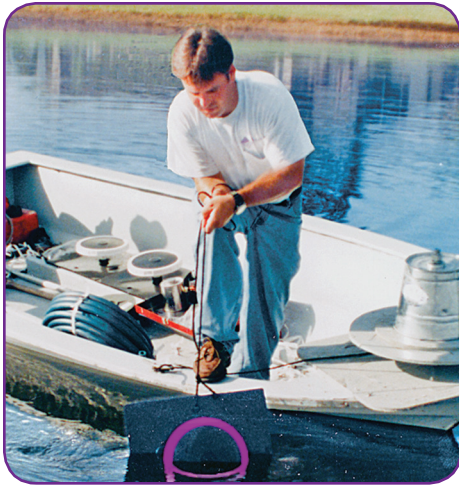
Placing Vertex AirStation™ into Heron Cay's lake.

After the design and installation of a Vertex aeration system consisting of 11 diffuser stations being fed by compressors totaling only 2-1/4 horsepower, Heron Cay was set up on a monitoring schedule to determine how lake dynamics were being affected. The results over the four month monitoring period were dramatic. Within days of initial start-up, the systems main objectives were beginning to be realized:

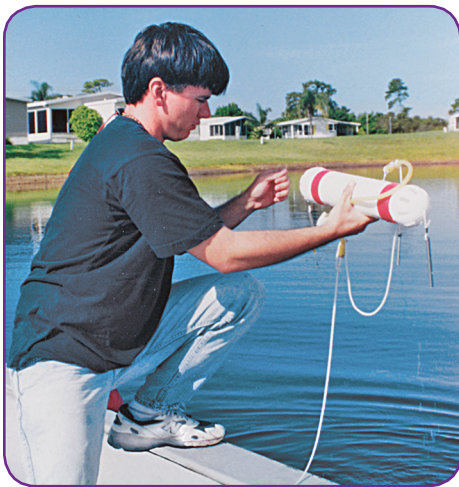
Gathering water samples. The lake was regularly monitored to determine water quality.

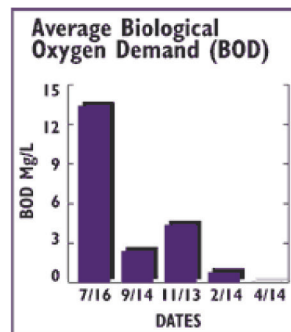
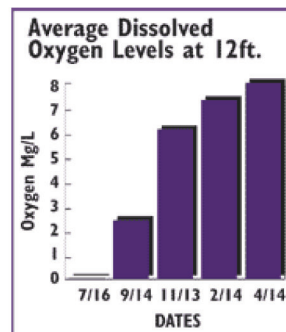
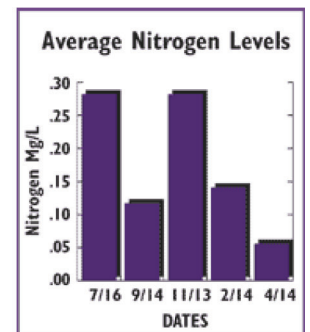
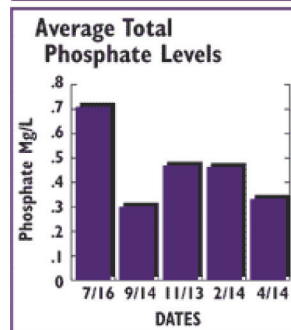
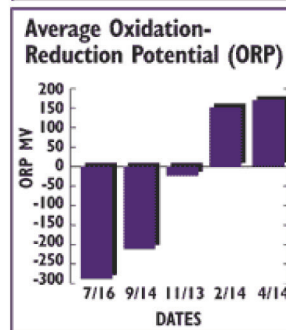
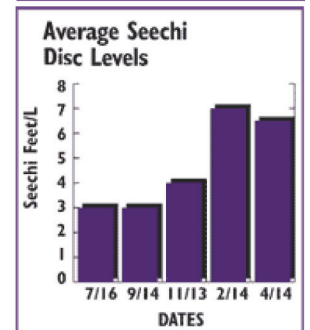
- The breakdown of temperature and oxygen stratification - the lake's water was being circulated.
- Increased oxygen levels throughout the entire water column - creating a healthy environment for both fish population and beneficial bacteria.
- Decreased the lake's Biochemical Oxygen Demand (BOD) - oxygen was no longer being consumed faster than it was being replenished.
- The residents of Heron Cay are no longer in danger of oxygen-related fish kills, odors have been eliminated and the lake is returning to natural, healthy conditions.
